TÜV Nederland QA B.V. report

2400-B-641 Badé B.V. Caravan Eco

Description of the test Safety assessment of Caravan Eco® 50 kg

Type Caravan ECO / 50 kg

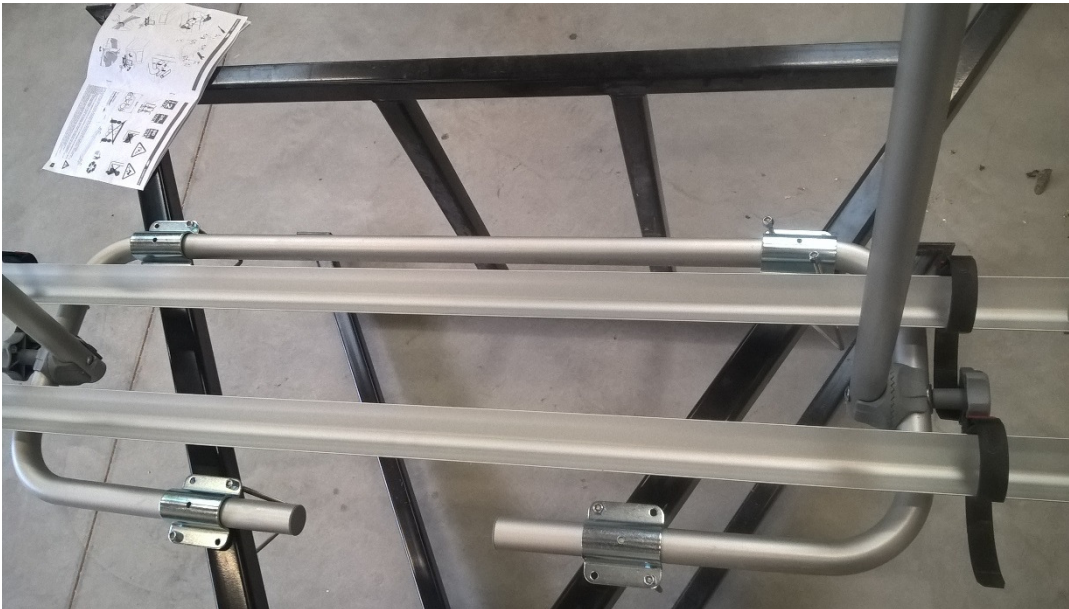
Photo 1.

The bike carrier is set-up according the instructions but the mounting on the Y frame is loose. This means that during the testing the materials will undergo impact forces.

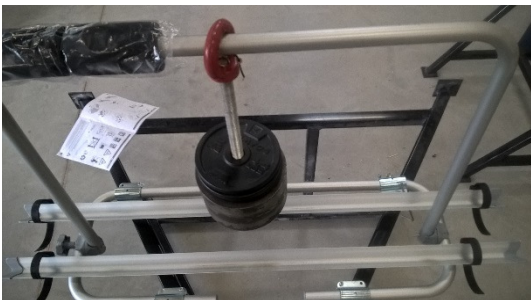
Photo 2, top view.

Based on the specification an static loadtest has been applied on the upstand bar. The weight is set to 50 kg.

There is no permanent deformation the aluminum frame under static load. This means that the wall thickness of the chosen tubes are withstanding the load.

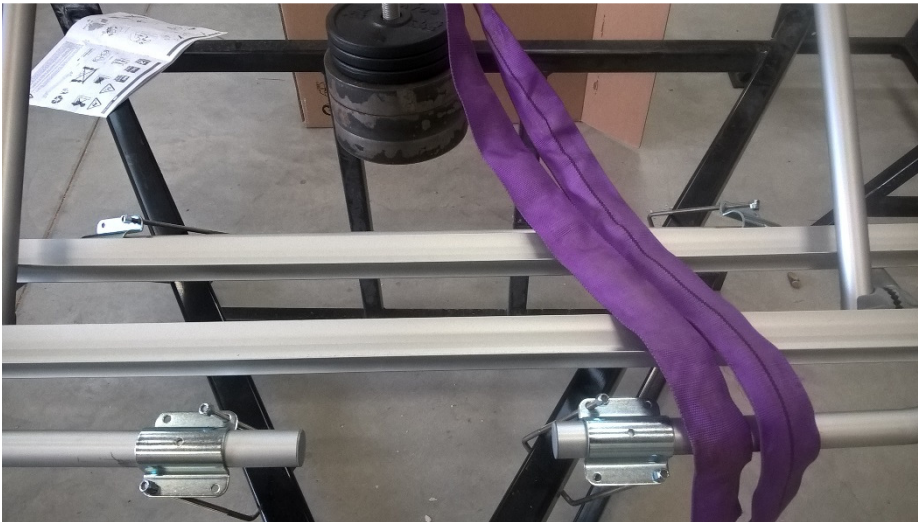
The next test is a pull test to bring the system in unbalance and visual inspect the results of the dynamic behavior of the materials in case the mounting would be extremely poor executed (worst case : abuse of the system in reference to manual).

Photo 4, situation after mechanical pull side wards (under 50 kg load).

The visual inspection has shown that the integrity of the system is maintained and slight deformation is present. This deformation is however acceptable and a result of the impact effect of the 'loose' mounting.

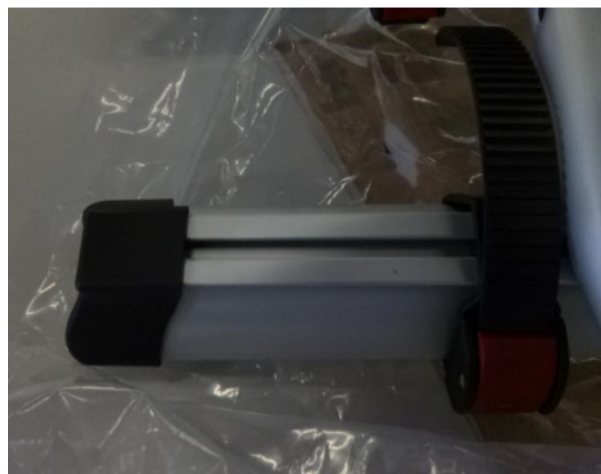
A very positive safeguard is to be remarked for the locking system of the wheels of the bike. These are made of robust materials and locking system and is fool-proof towards the use.

Photo 5, lock device for the bicycle wheels
