FIAMMA F65S
FIAMMA F65L

F65 • Maintenance and repairs

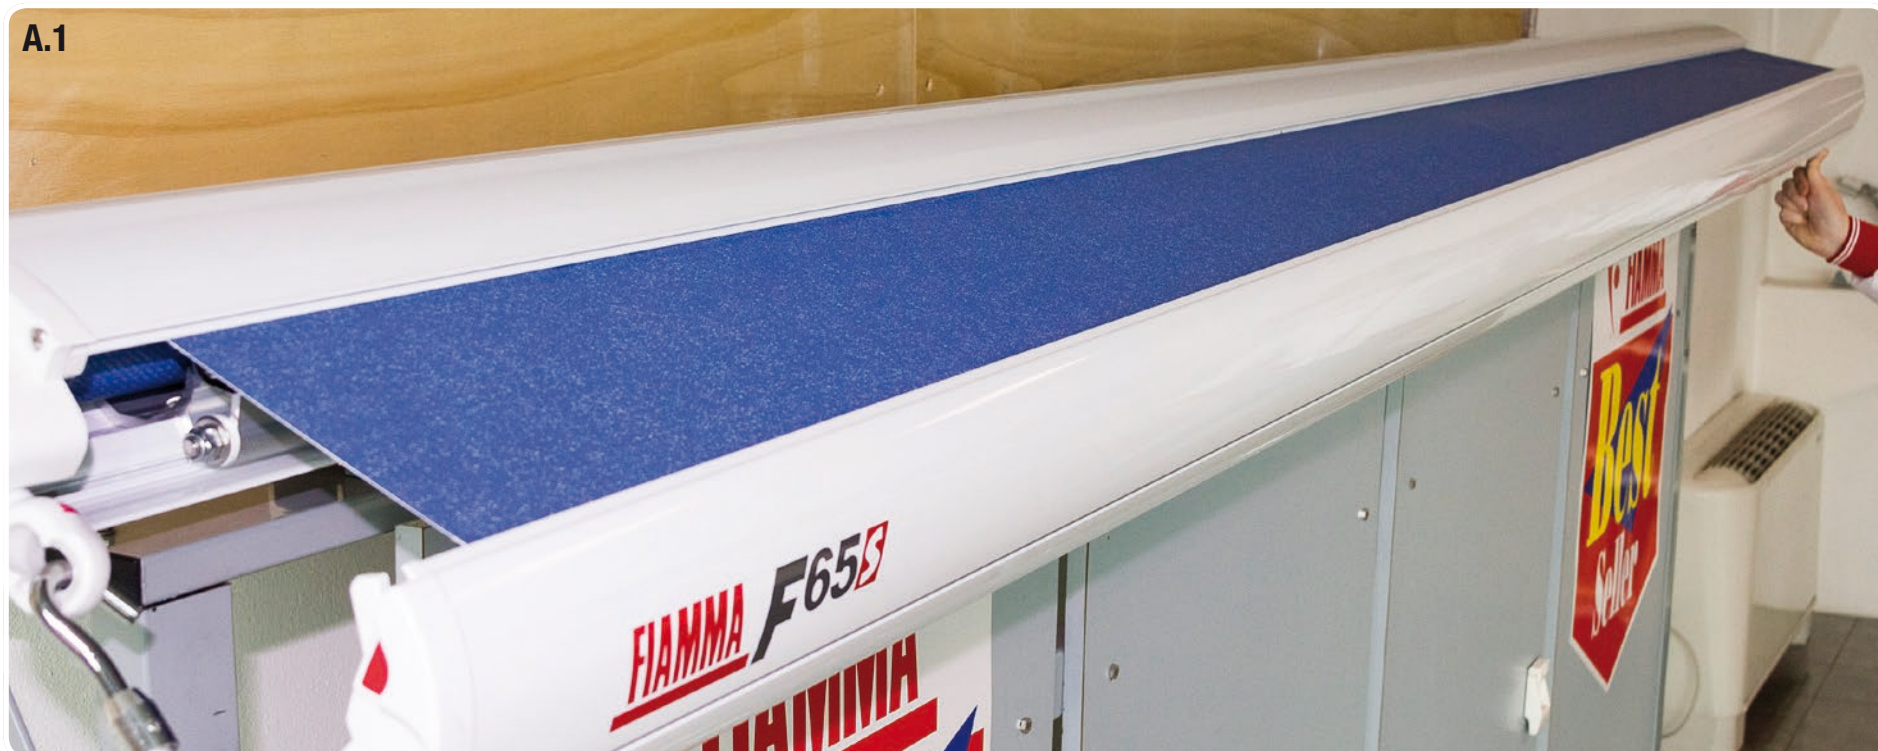
A.1 • The lead bar of the awning is lower on one side (left or right).

Warning: *Ensure that shock absorber bolts are not blocked in the upper slots.*

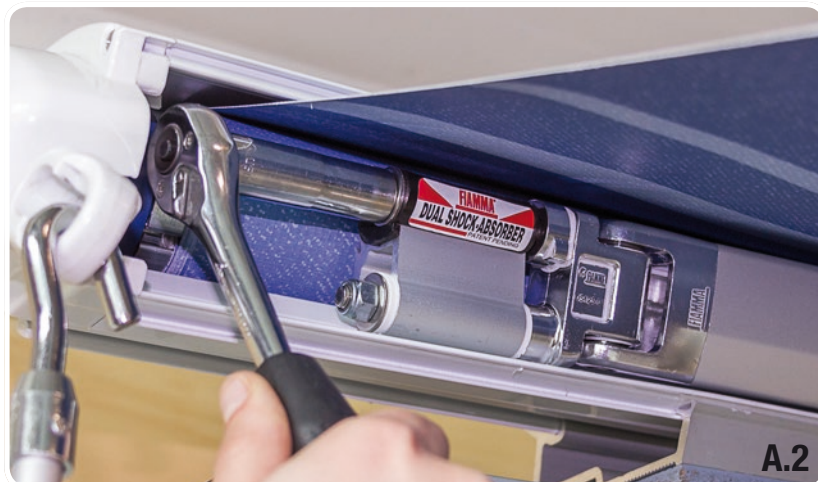
A.2 • Adjust the upper bolt of the Dual Shock Absorber by tightening or loosening slightly on the side where the lead bar is lower (wrench 10mm).

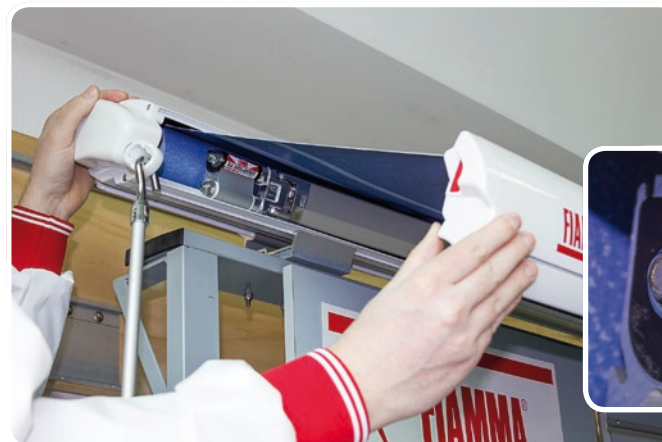
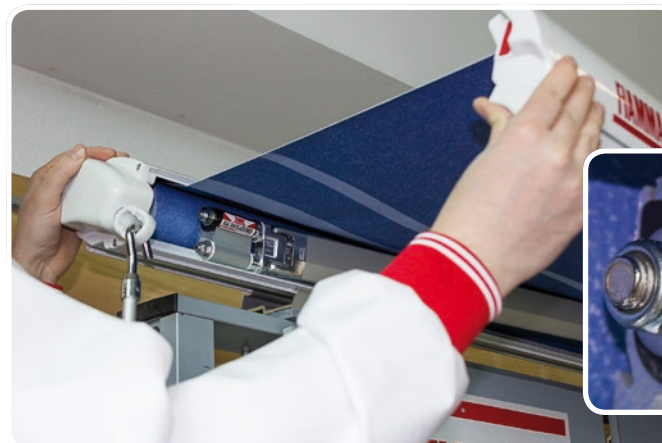
B.1 • Fully open the awning.

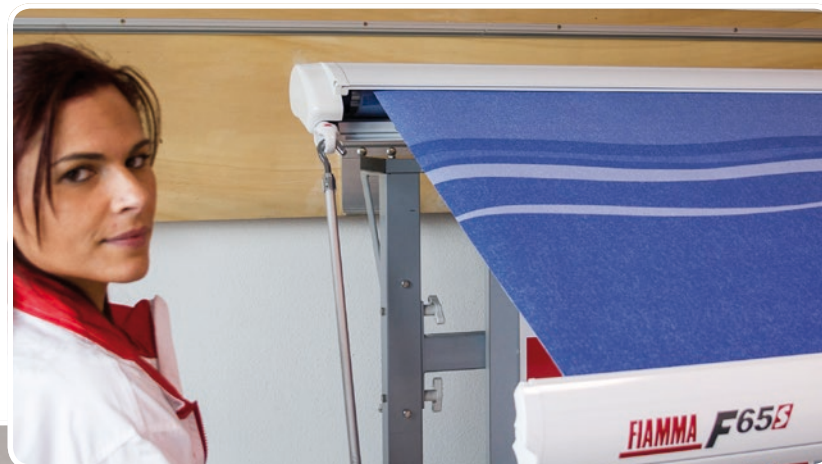
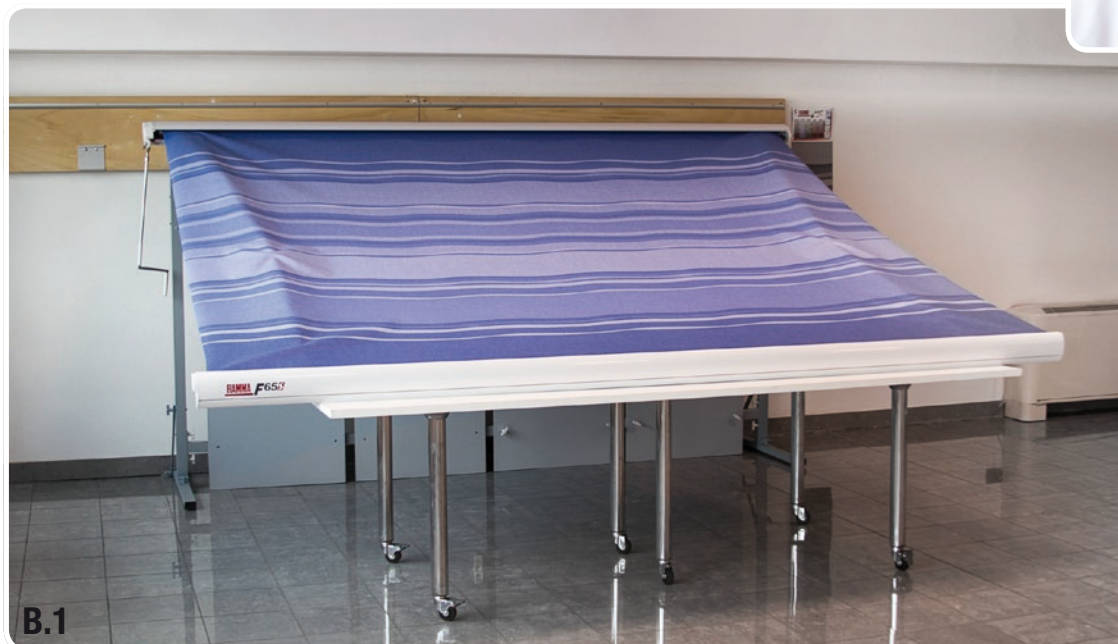
B.1

B.2 • Remove the screws on both of the end covers as shown in images.

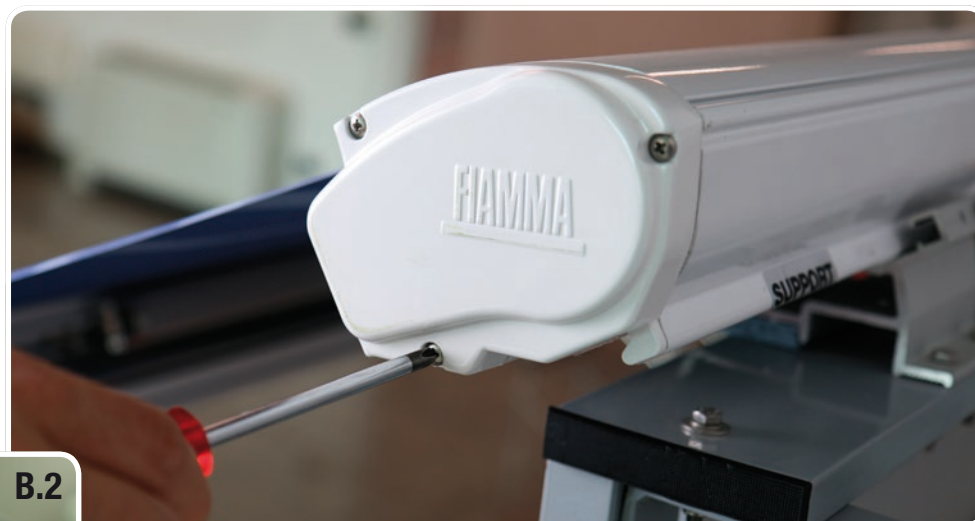
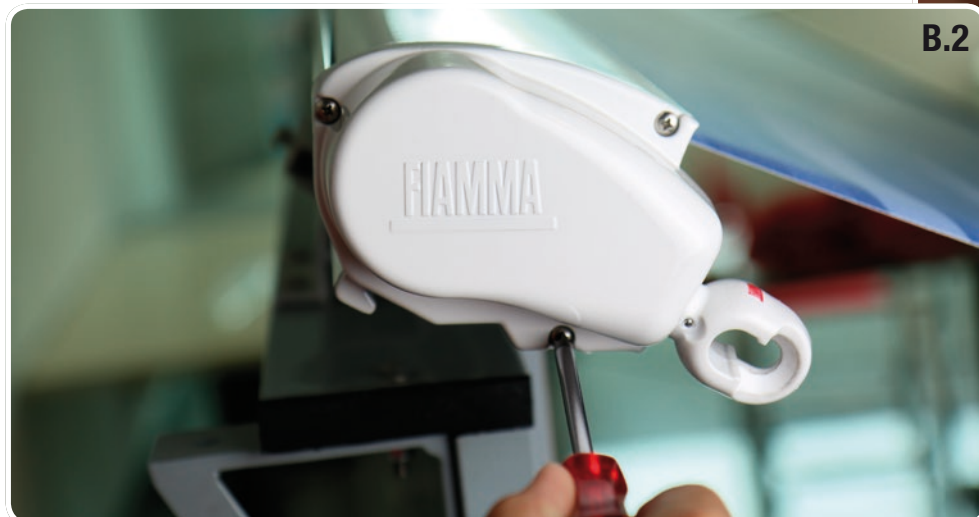
B.2

B.3 • Unhook the upper case cover by lifting it upwards.

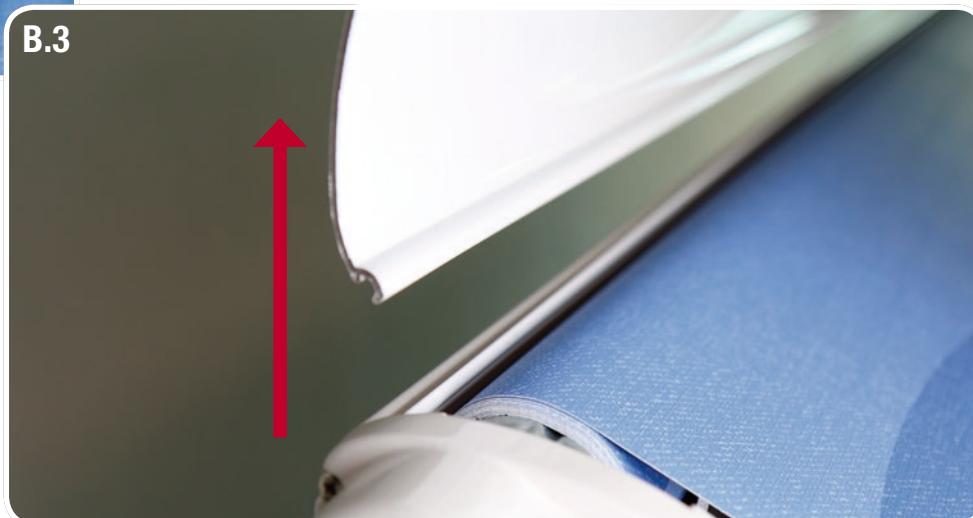
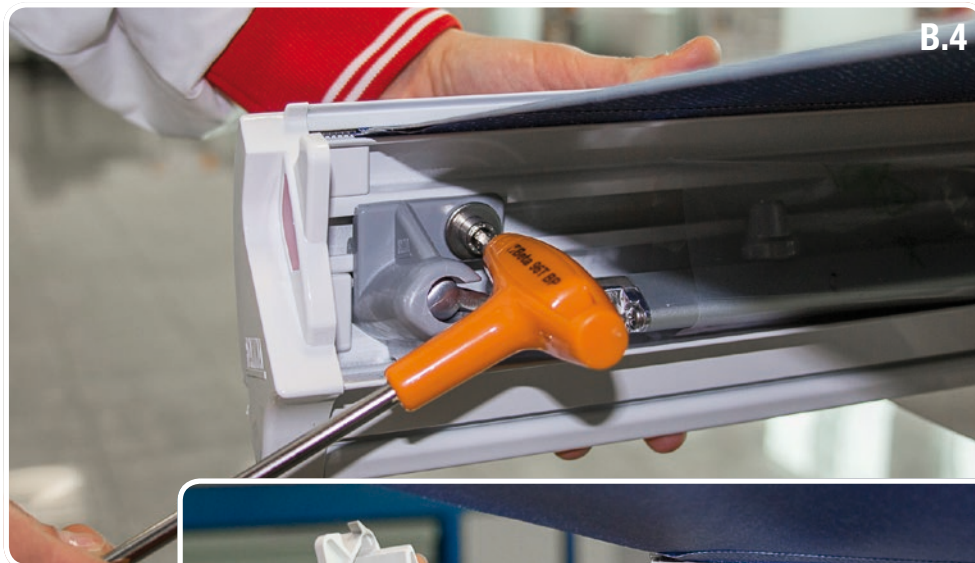
B.4 • Remove the end caps and the legs of the lead bar (Allen wrench 5mm).

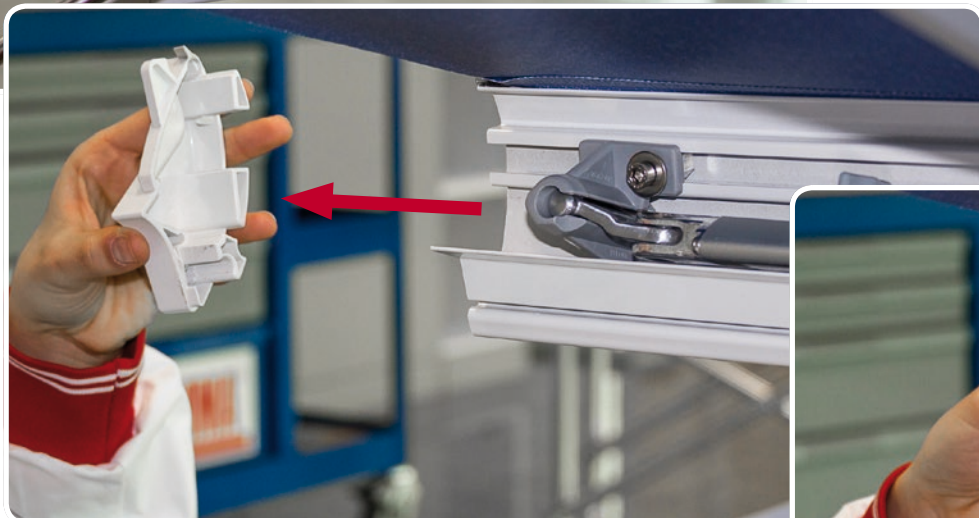
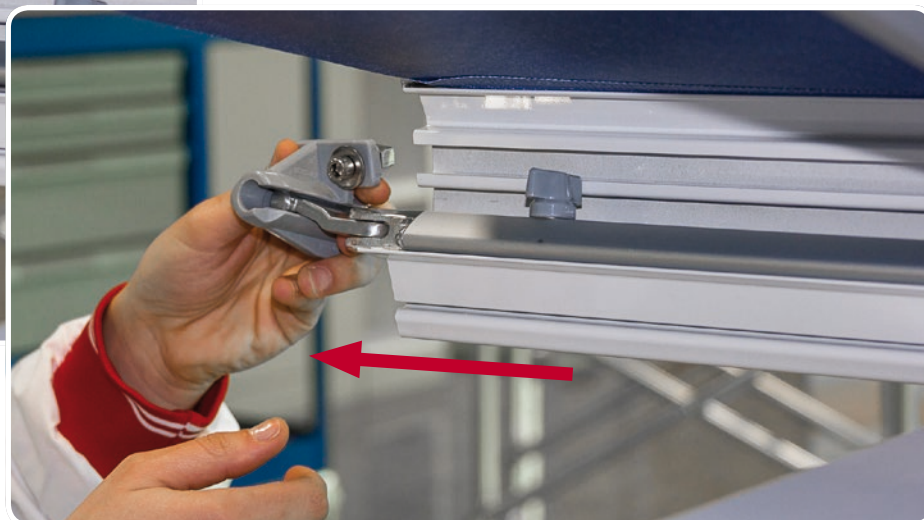
B.5 • Remove the screws that secure the fabric on both sides of the lead bar.

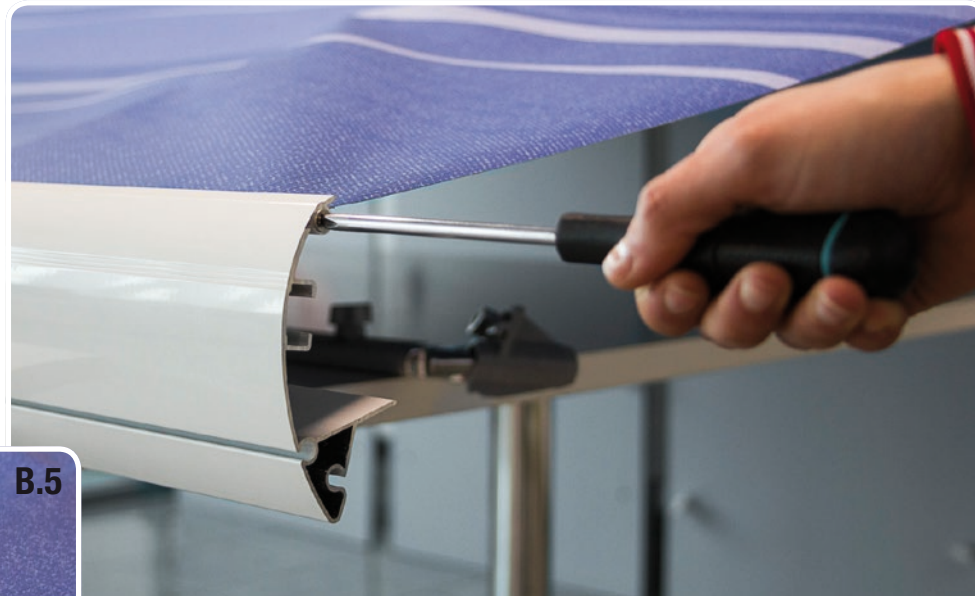
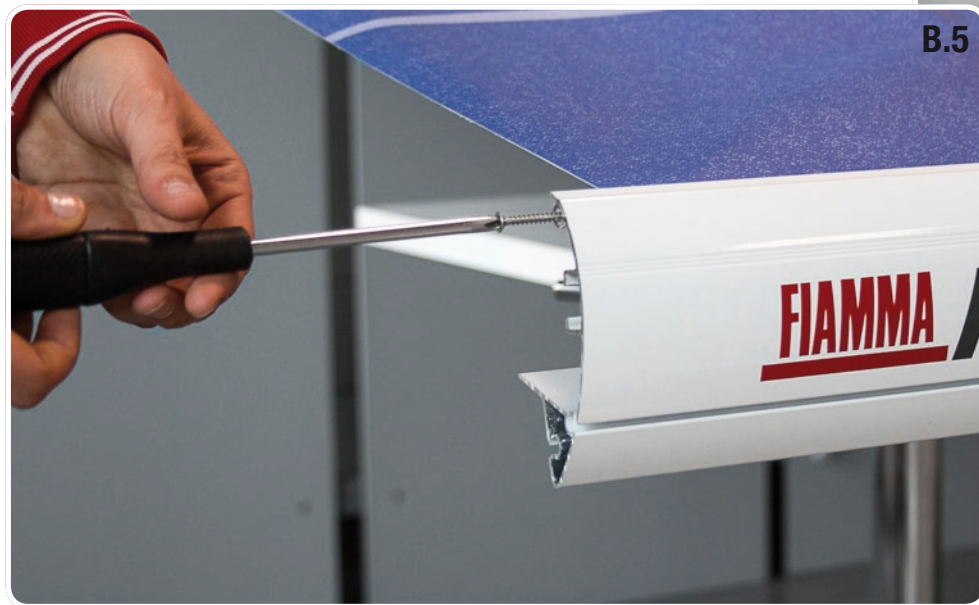
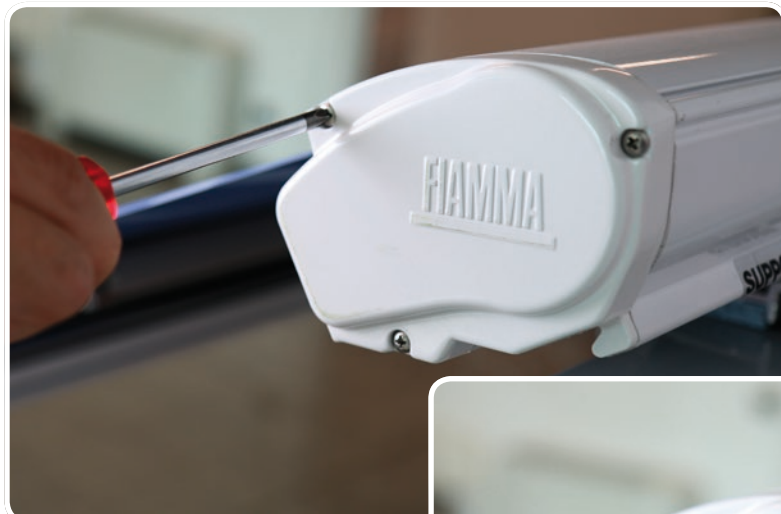
B.6 • Remove the right end cap of the case box.

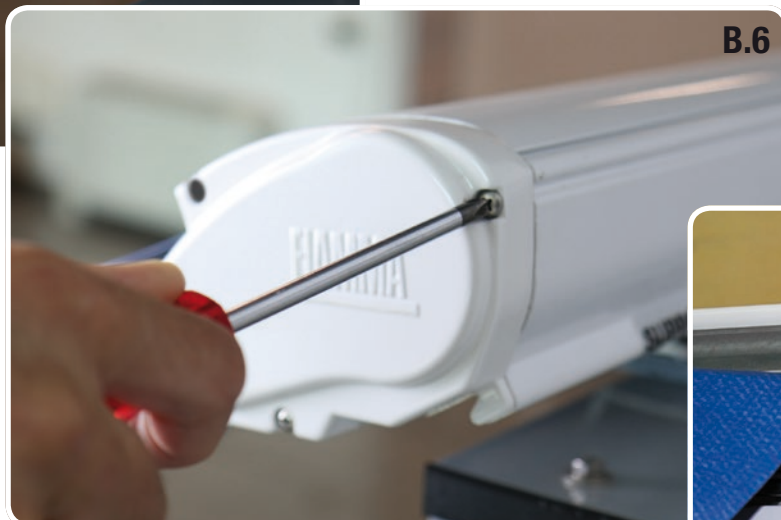
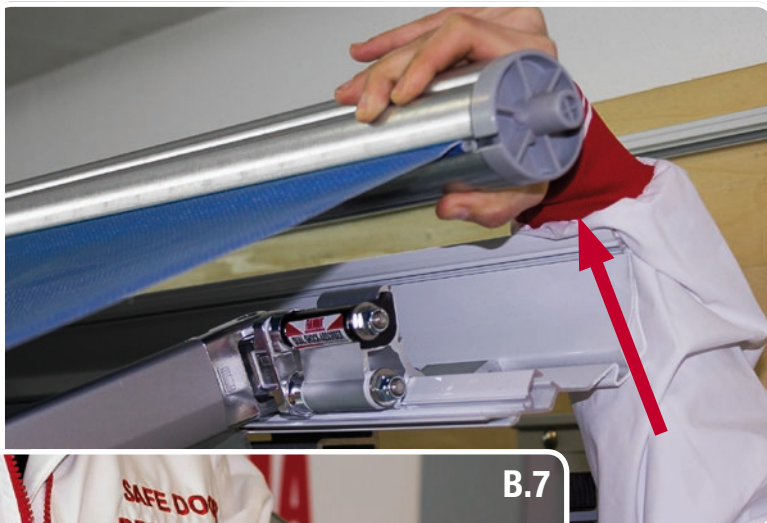
B.7 • Lift the roller tube and remove it from the left end cap and roll the fabric up.

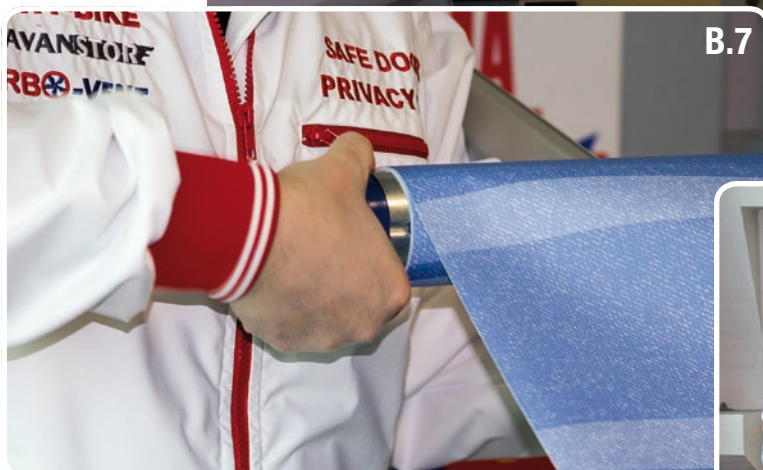
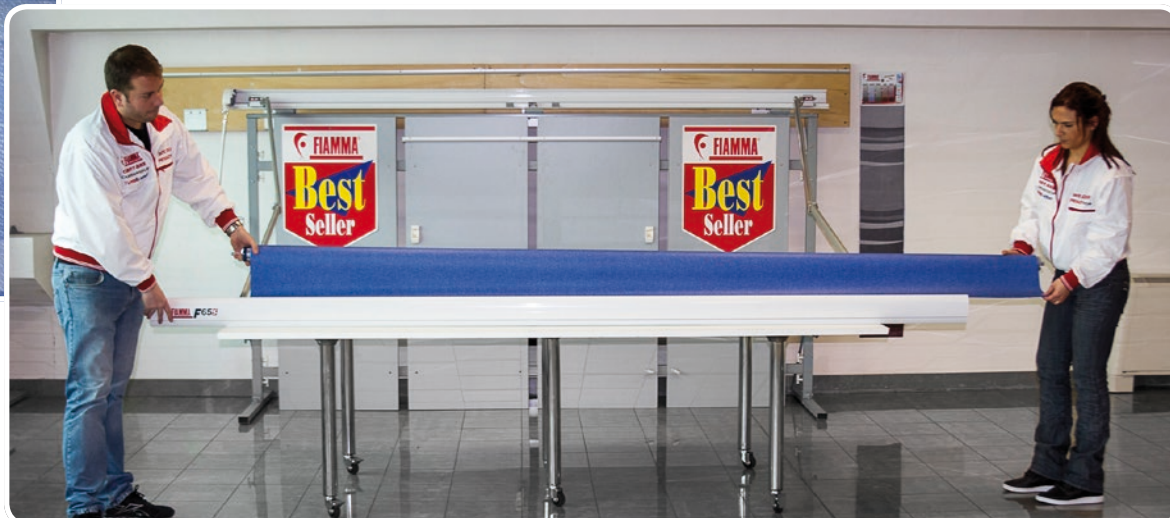
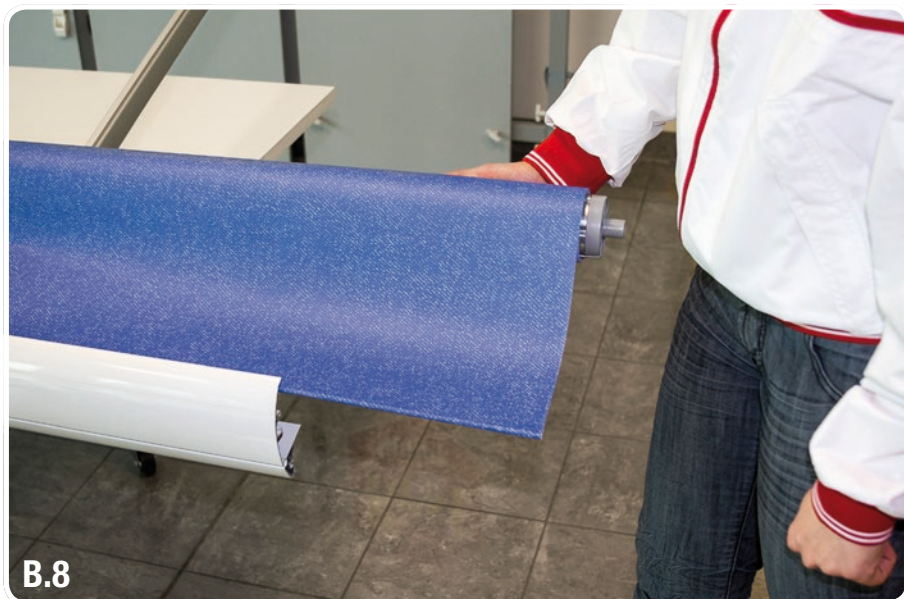
B.8 • Remove the roller tube from the lead bar of the awning.

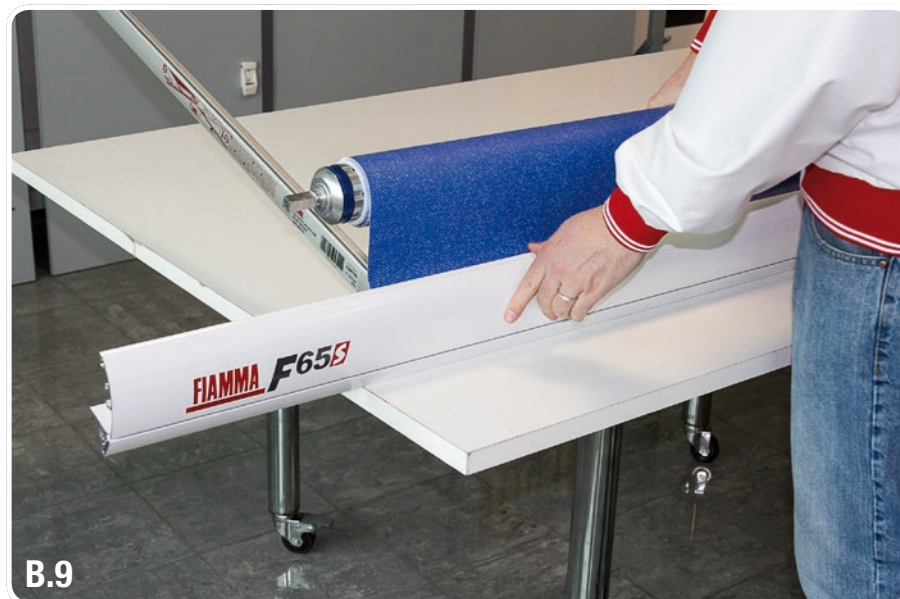
B.9 • Slide the new fabric in the lead bar of the awning.

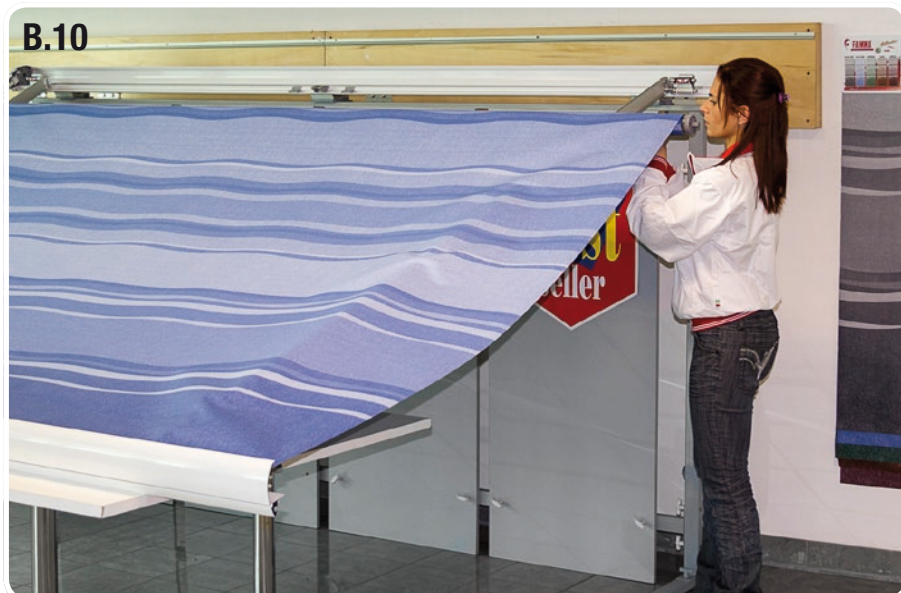
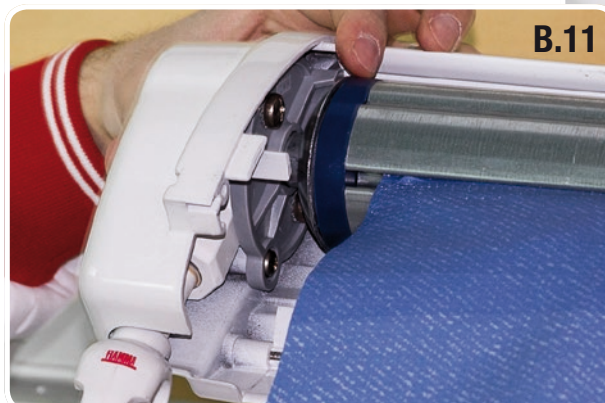
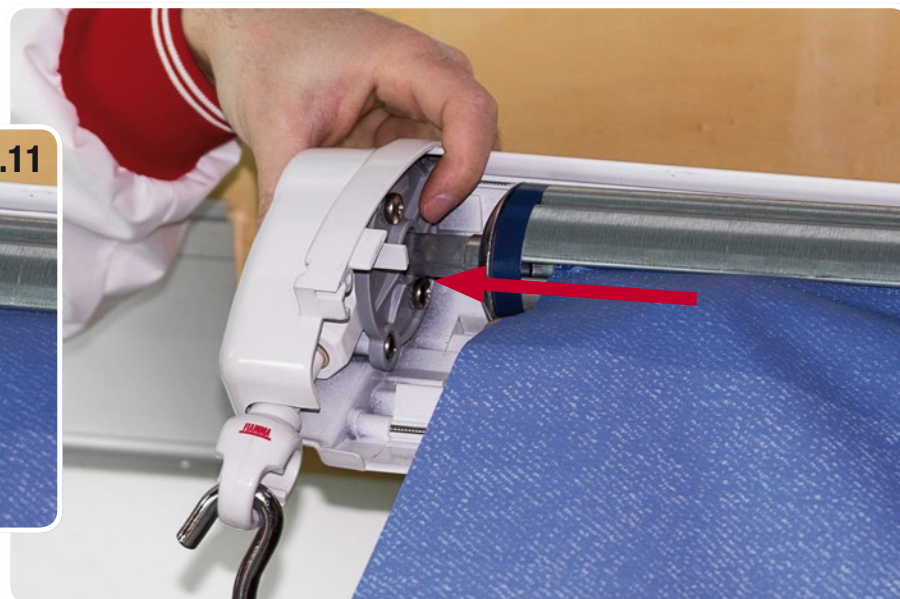
B.10 • Unroll the new fabric.

B.11 • Insert the roller tube in the left end cap.

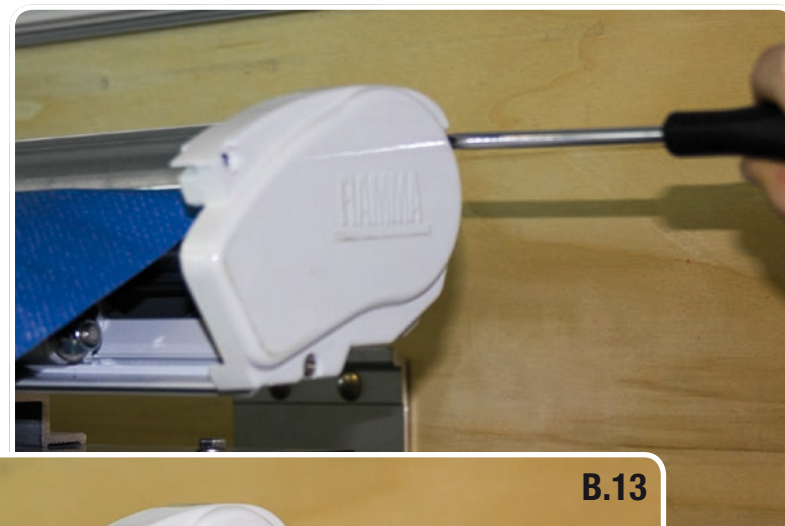
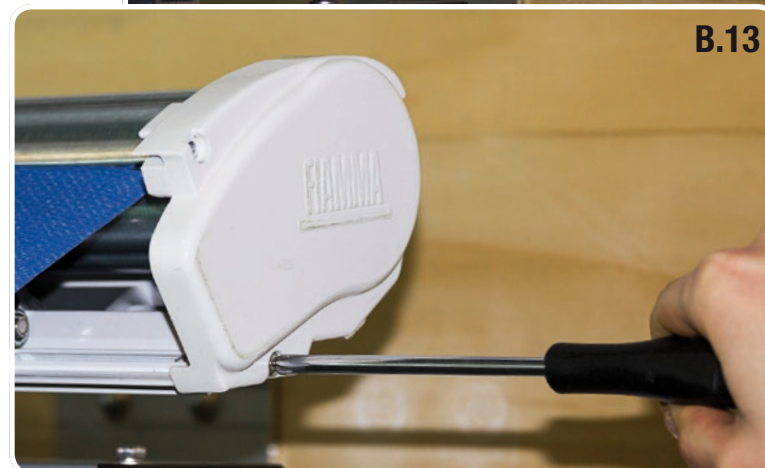
B.13 • Fasten the right end cap with its two screws.

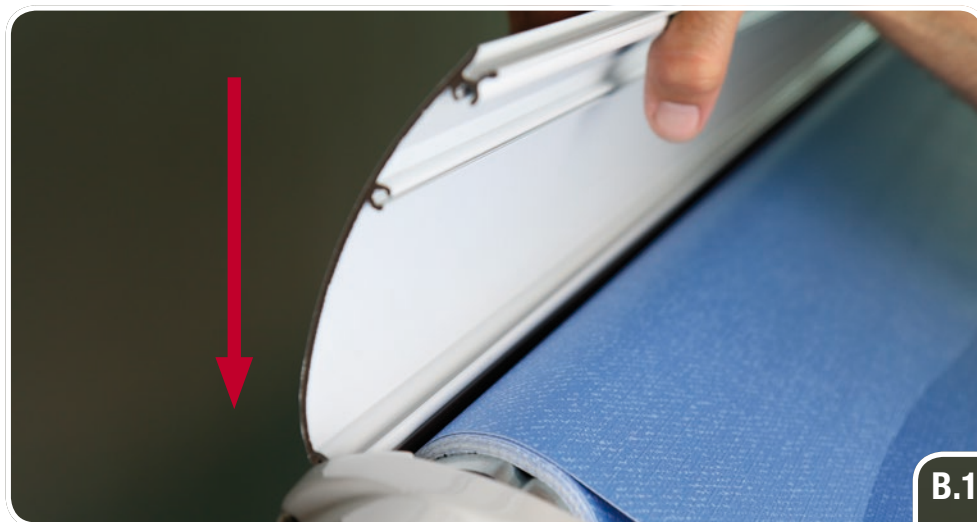
B.14 • Reassemble the cover on the case.

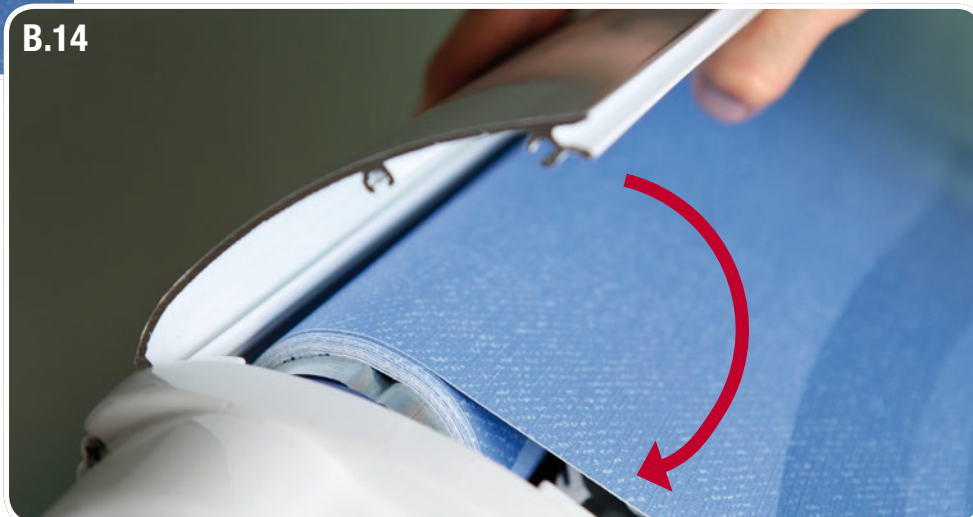
B.15 • Fasten the cover of the case with its two screws.

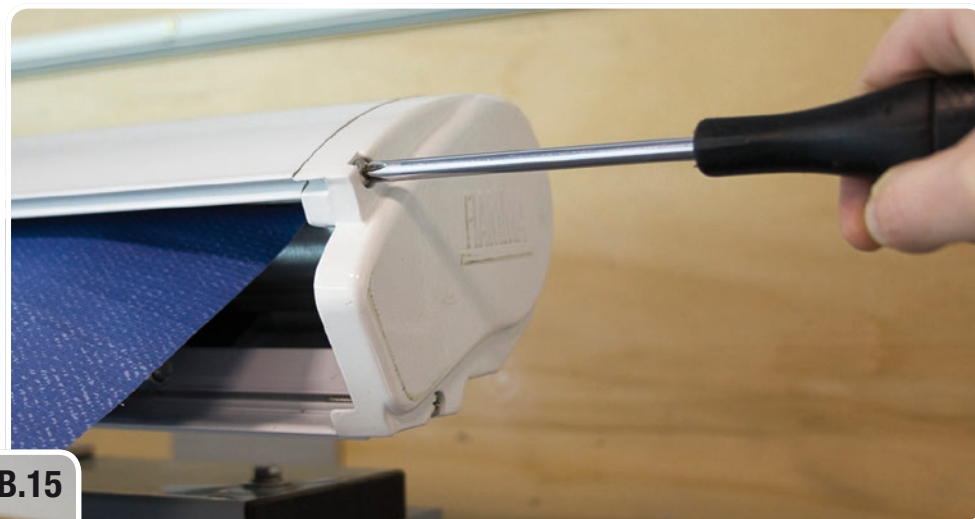
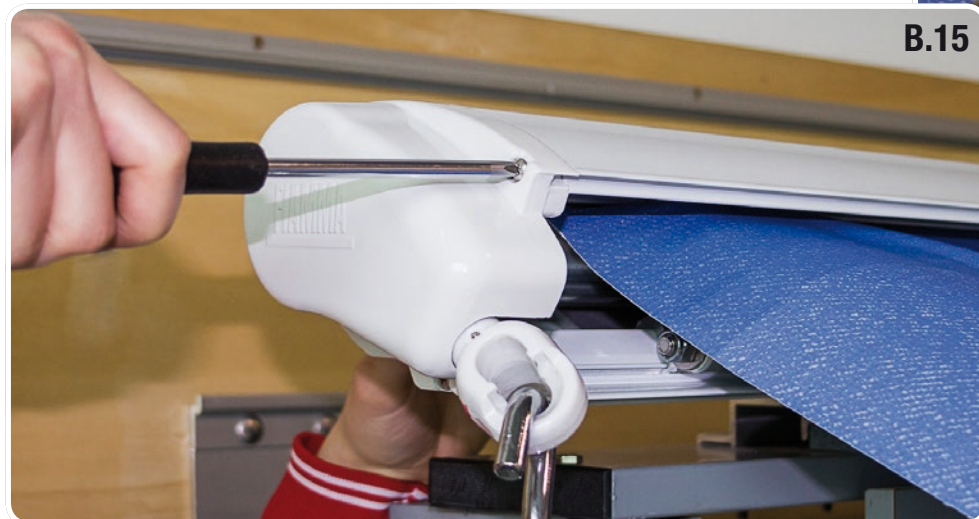
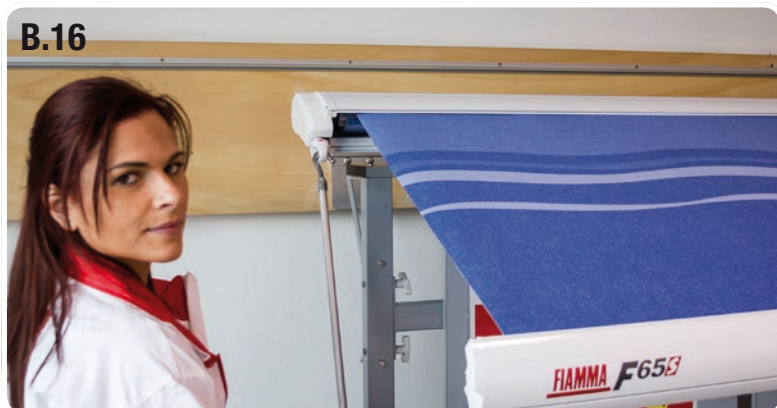
B.16 • Close the awning.

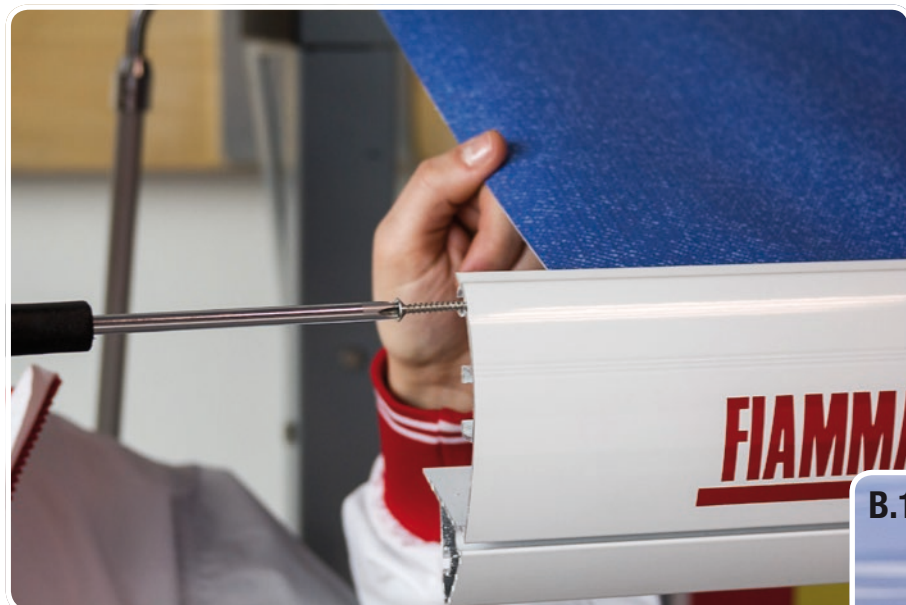
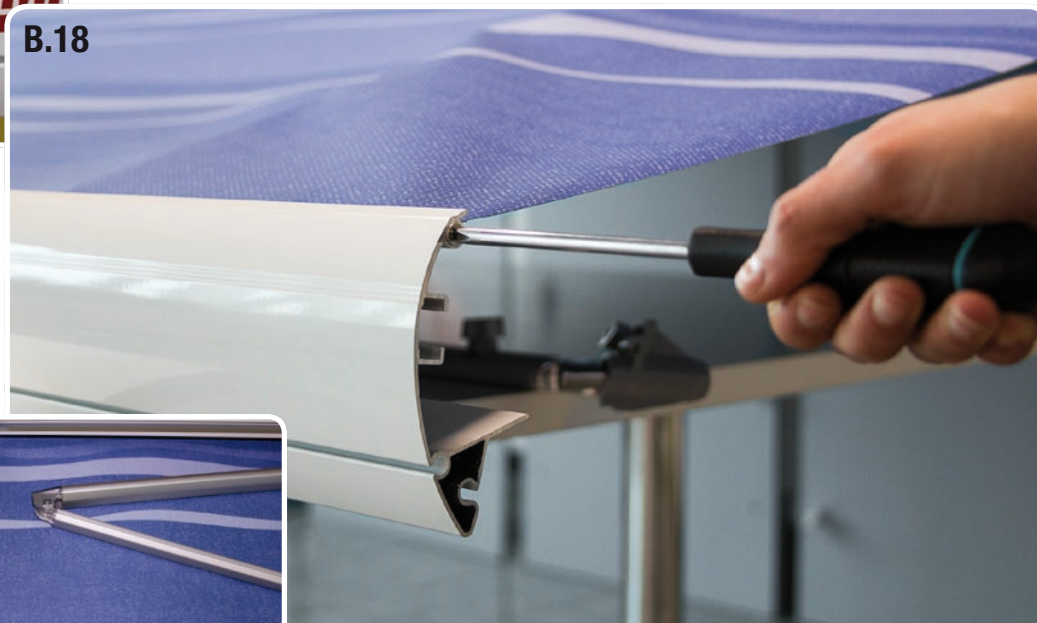
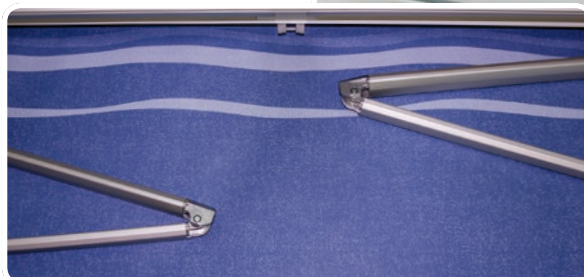
B.18 • Fasten the fabric to the lead bar with its two screws; verify that the arms remain aligned.

After tightening the screws, if the arms are not aligned, further tighten the screw on the side where the arm is closer to the lead bar.

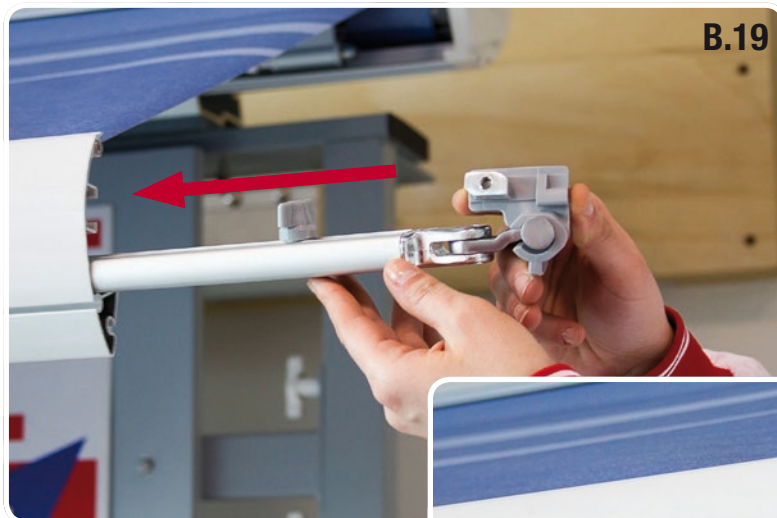
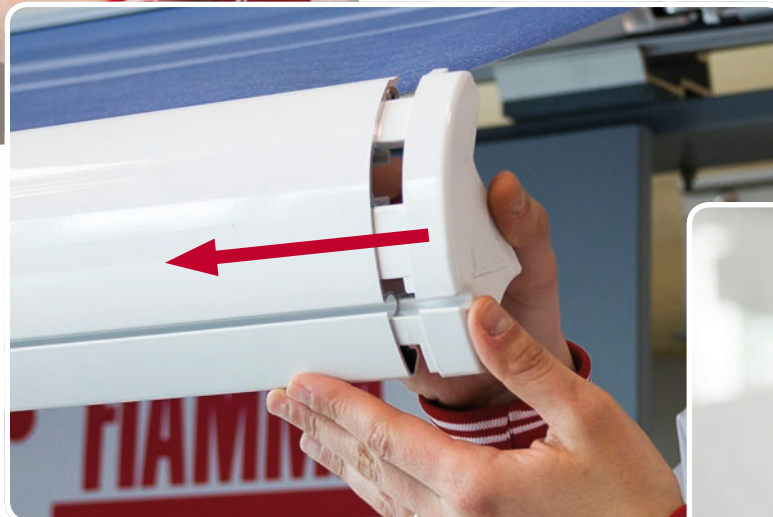
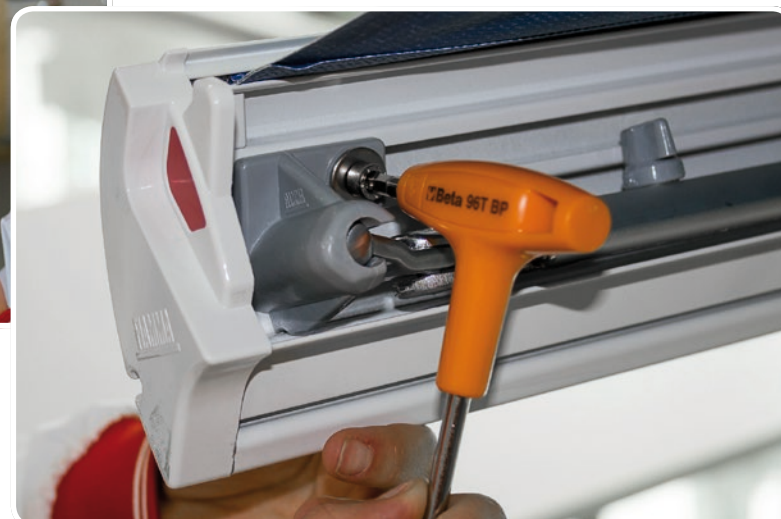
B.19 • Reassemble legs and end caps on the lead bar.
